Repetitive inappropriate implantable cardioverter-defibrillator shocks due to insulation failure with externalized conductor cables of a Biotronik Linx SD ICD lead

Tobias Reichlin*, Michael Kühne, and Christian Sticherling

Division of Cardiology, University Hospital Basel, Petersgraben 4, Basel CH-4031, Switzerland

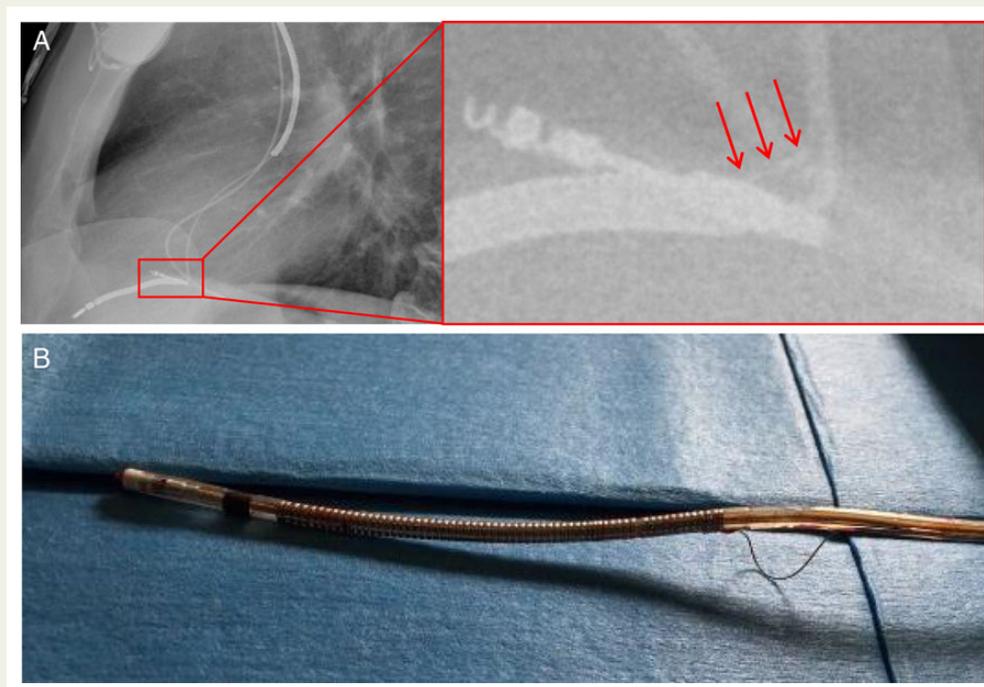
A 54-year-old man with non-ischaemic dilated cardiomyopathy underwent implantation of an ICD for primary prevention in 2007 utilizing a dual-coil Biotronik Linx SD 65/16 lead. He has since had a generator change in 2012 with a St Jude Medical Fortify ST DR 2235-40 defibrillator. He had received several appropriate ICD therapies for ventricular tachycardias in the past. In January 2015, he presented with 17 repetitive ICD shocks. Interrogation of the ICD showed noise resulting in erroneous detection of VF causing repetitive inappropriate ICD shocks. Implantable cardioverter-defibrillator therapies were turned off. Ventricular sensing was 11.3 mV, pacing impedance 490 Ω , and shock impedance 40 Ω , all unchanged from prior testing. Pacing threshold could not be determined reliably because pacing resulted in large amounts of ventricular noise. In the device memory, several episodes of noise resulting in erroneous detection of non-sustained VF episodes had been documented, but this went unnoticed, because no home monitoring system had been used. In the lateral view of a chest X-ray externalization of a conductor cable just proximal to the distal coil was suspected (Figure 1A, arrows). A lead extraction was performed and inspection of the easily extractable lead showed an insulation failure with externalized pace-sense conductor cables (Figure 1B) proximal to the distal coil as the putative source of the noise. A novel single-coil ICD lead was implanted and the patient has done well since.

Figure 1 (A) Lateral chest X-ray of the ICD system. In the magnified section, the externalized conductor cable can be seen (arrows). (B) Biotronik Linx SD ICD lead with insulation failure and an externalized conductor cable.
