Complete tear-off of a Riata dual coil lead tip

Julia W. Erath^{1†}, Nadejda Monsefi^{2†}, and Stefan H. Hohnloser^{1†*}

¹Division of Clinical Electrophysiology, Department of Cardiology, J. W. Goethe University, Theodor-Stern-Kai 7, Frankfurt D 60590, Germany and ²Department of Cardio-Thoracic Surgery, J. W. Goethe University, Frankfurt, Germany

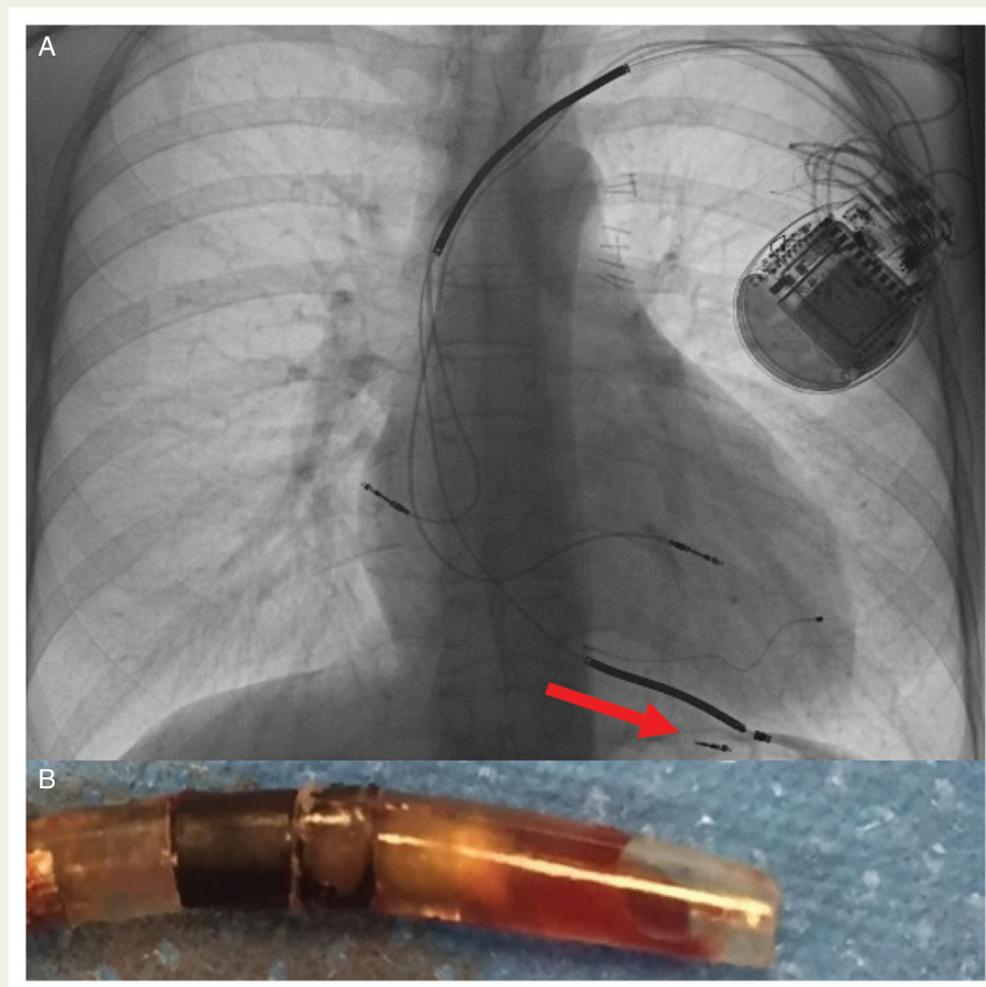
Figure 1 (A) Chest X-ray showing complete tear-off of the Riata lead tip. (B) Fractured site of the Riata lead.

This case demonstrates that tear-off of the tip of a Riata ICD lead can occur. Whether this was caused by the chest trauma, remains speculative. Although measurements of lead parameters might indicate optimal lead function, it seems prudent to replace such leads, particularly in younger patients.

Nevertheless, we decided and performed a transvenous removal of the damaged shock and the pace-sense electrodes from the RV by utilizing an excimer laser extraction system and replaced them by a new DF-4 ICD lead. The fractured site of the Riata lead is shown in *Figure 1B*.
