## Complete tear-off of a Riata dual coil lead tip

Julia W. Erath<sup>1†</sup>, Nadejda Monsefi<sup>2†</sup>, and Stefan H. Hohnloser<sup>1†\*</sup>

<sup>1</sup>Division of Clinical Electrophysiology, Department of Cardiology, J. W. Goethe University, Theodor-Stern-Kai 7, Frankfurt D 60590, Germany and <sup>2</sup>Department of Cardio-Thoracic Surgery, J. W. Goethe University, Frankfurt, Germany

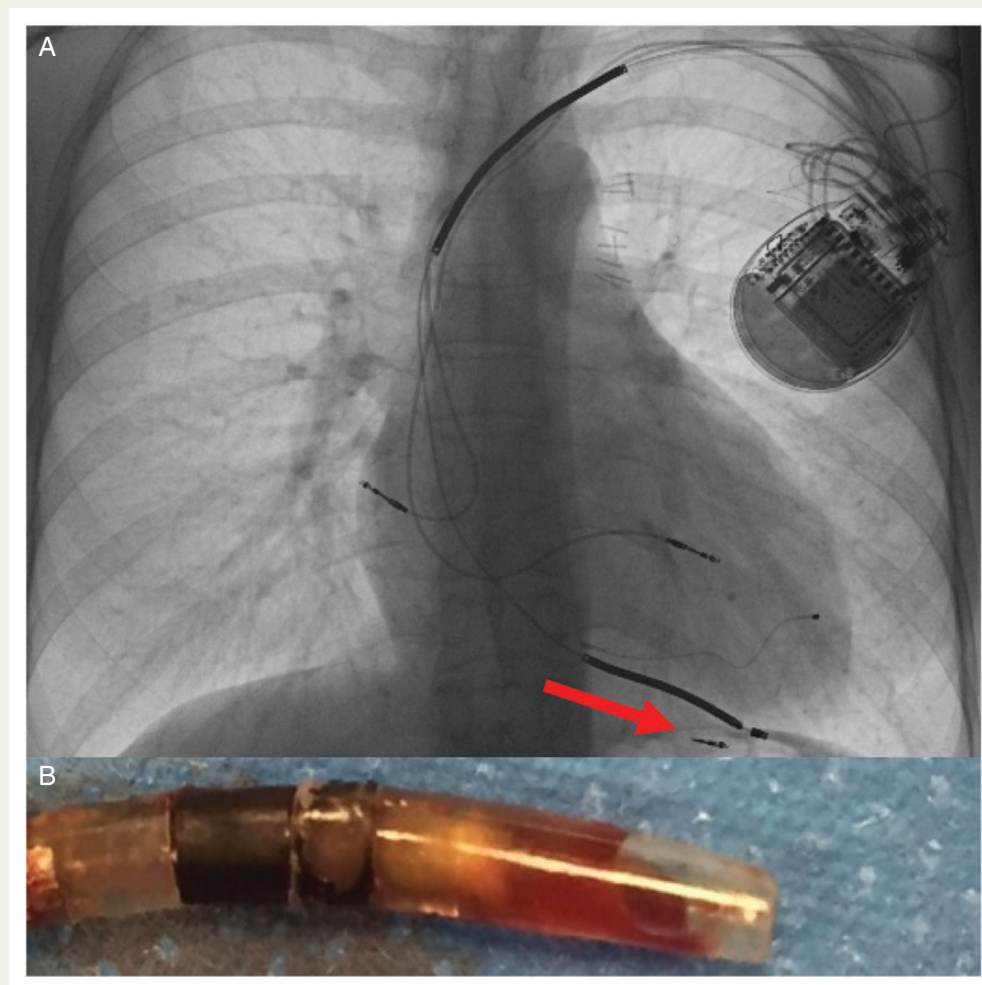
**Figure 1** (A) Chest X-ray showing complete tear-off of the Riata lead tip. (B) Fractured site of the Riata lead.

Nevertheless, we decided and performed a transvenous removal of the damaged shock and the pace-sense electrodes from the RV by utilizing an excimer laser extraction system and replaced them by a new DF-4 ICD lead. The fractured site of the Riata lead is shown in *Figure 1B*.

This case demonstrates that tear-off of the tip of a Riata ICD lead can occur. Whether this was caused by the chest trauma, remains speculative. Although measurements of lead parameters might indicate optimal lead function, it seems prudent to replace such leads, particularly in younger patients.
