# *Echo evaluation of valve prostheses*

## Recommendations for Evaluation of Prosthetic Valves With Echocardiography and Doppler Ultrasound

A Report From the American Society of Echocardiography's Guidelines and Standards Committee and the Task Force on Prosthetic Valves, Developed in Conjunction With the American College of Cardiology Cardiovascular Imaging Committee, Cardiac Imaging Committee of the American Heart Association, the European Association of Echocardiography, a registered branch of the European Society of Cardiology, the Japanese Society of Echocardiography and the Canadian Society of Echocardiography, Endorsed by the American College of Cardiology Foundation, American Heart Association, European Association of Echocardiography, a registered branch of the European Society of Cardiology, the Japanese Society of Echocardiography, and Canadian Society of Echocardiography

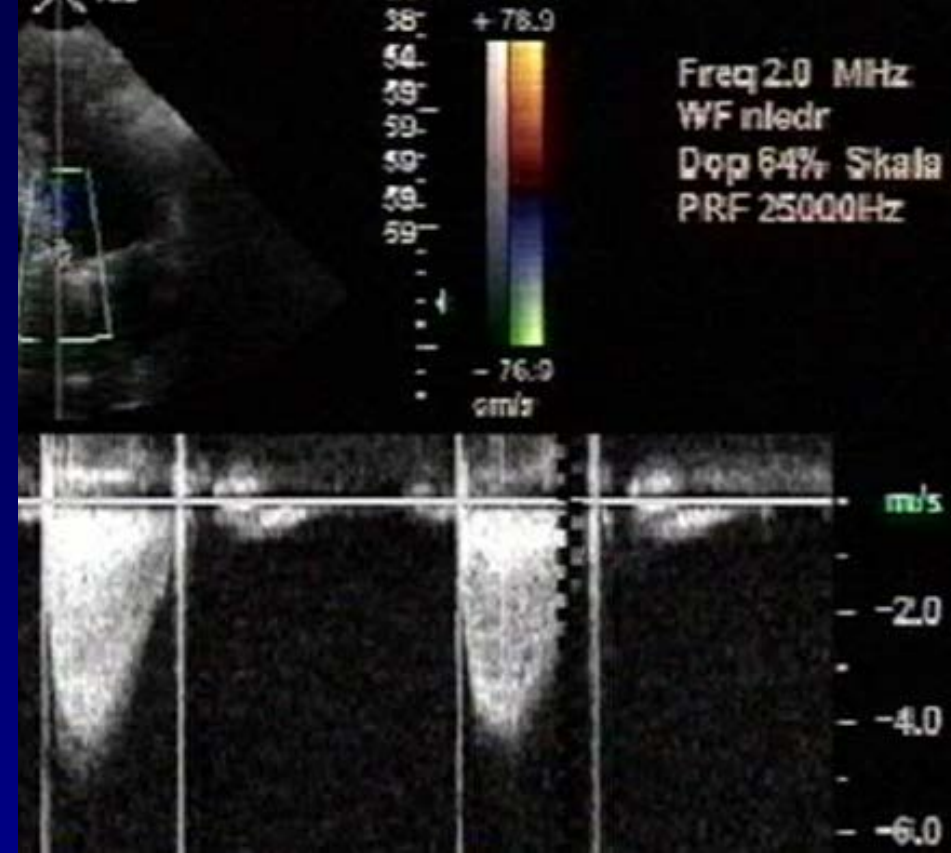
60yr old patient w bileaflet AVR  
max./mean 68 / 38 mmHg

Valve	Size	Peak gradient (mm Hg)	Mean gradient (mmHg)	Effective orifice area (cm <sup>2</sup> )
St Jude Medical Standard <i>Bileaflet</i>	19	42.0± 10.0	24.5± 5.8	1.5± 0.1
	21	25.7± 9.5	15.2± 5.0	1.4± 0.4
	23	21.8± 7.5	13.4± 5.6	1.6± 0.4
	25	18.9± 7.3	11.0± 5.3	1.9± 0.5
	27	13.7± 4.2	8.4± 3.4	2.5± 0.4
	29	13.5± 5.8	7.0± 1.7	2.8± 0.5

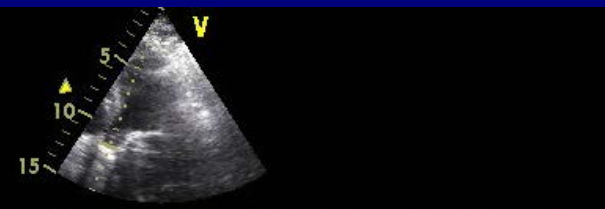
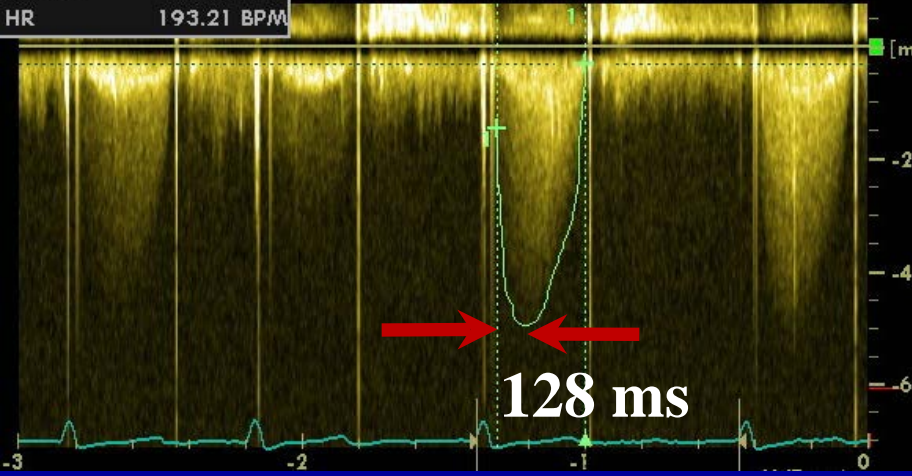
**55yr old woman with double valve replacement due to rheumatic disease**

AV Vmax	4.96 m/s
AV Vmean	3.91 m/s
AV maxPG	98.44 mmHg
AV meanPG	65.99 mmHg
AV VTI	121.53 cm
HR	193.21 BPM

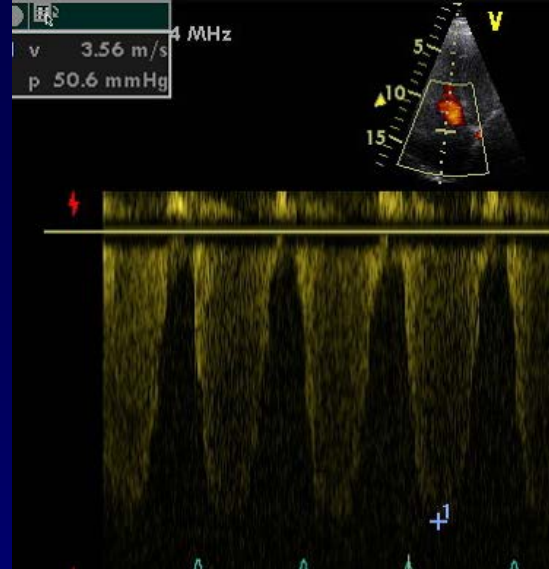
4 MHz  
v 3.56 m/s  
p 50.6 mmHg

→  
**AT 125 ms**

**50 yr old pt 4 years  
after AVR with stentless  
pericardial valve**

**now new LV dysfunction  
(EF 10%), severe MR,  
max.gradient 40 mmHg,  
cardiogenic shock**

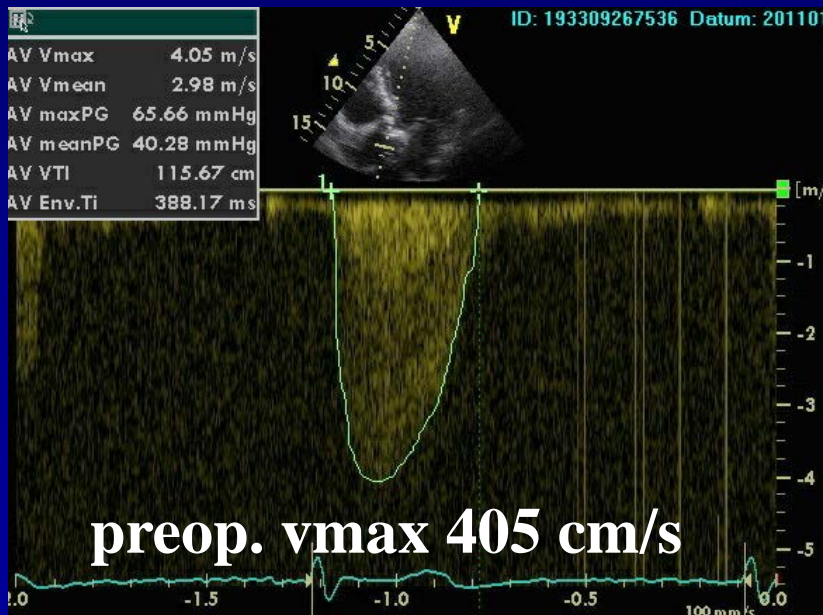
AS  $\rightarrow$  AVR (Nr.21 bioprosthesis) morphologically good function

$$\text{eff.orifice area} = 3,14 \cdot 35 / 81 = 1.4 \text{ cm}^2; \rightarrow \text{EOI} = 0.67 \text{ cm}^2/\text{m}^2$$

- prosthesis functions normally but is too small for patient
- effective orifice area  $< 0.85 \text{ cm}^2/\text{m}^2$
- relevant only in AVR
- unclear prognostic significance

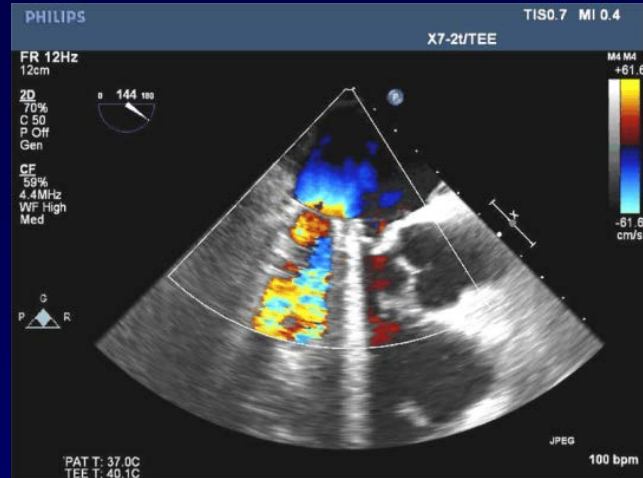
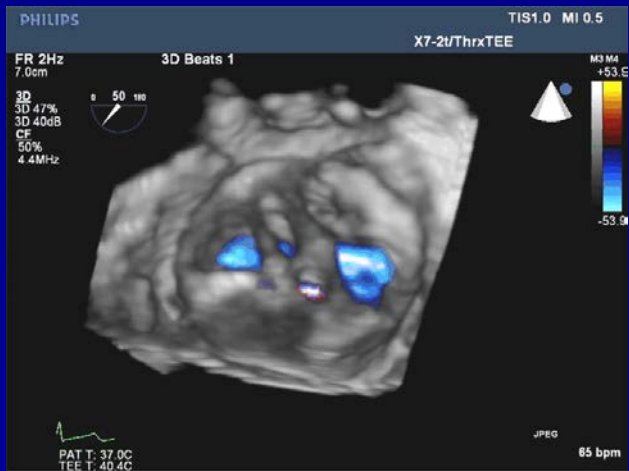
**Medtronic-Hall**

**Flachskampf JACC 91; 18:1493**
