Developing a crush: acute implantable cardioverter-defibrillator lead insulation break in a patient with multiple leads

Royal Brompton and Harefield Hospitals, London, UK

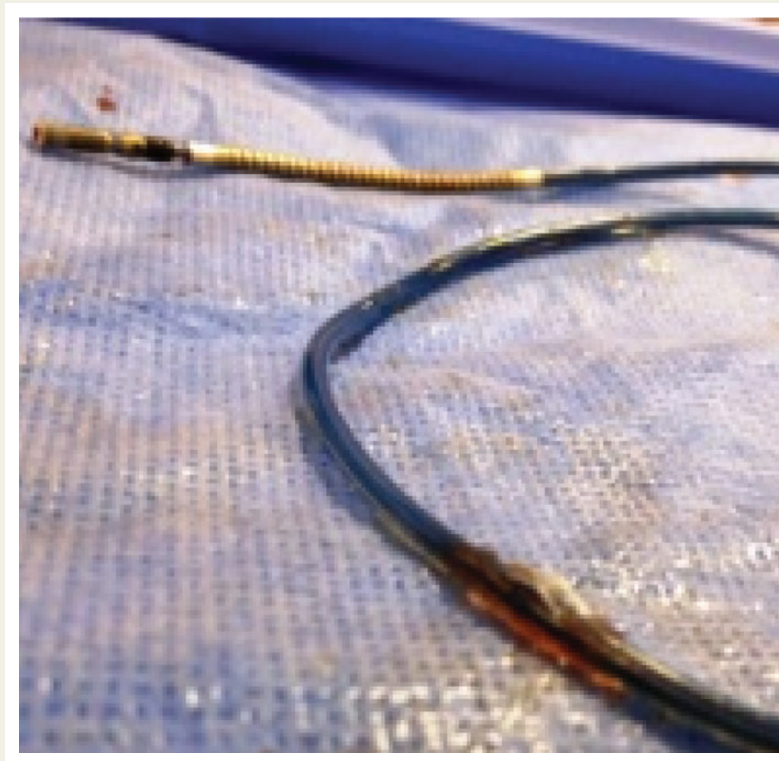
Six weeks later, the patient presented with falls, and dizziness on elevating his left arm. Cardiac monitoring revealed ventricular standstill during this manoeuvre. The defibrillator lead was explanted manually and found to have extensive insulation damage (see Figure 1). The old right ventricular and atrial leads were also explanted, and a new St Jude 7120Q Durata defibrillator lead implanted.

Figure 1 Explanted defibrillator lead showing insulation break.

This case illustrates an acute defibrillator lead crush injury, leading to an insulation break and noise inhibition of pacing. It is unusual because the damage occurred so soon after implant, and this patient with advanced heart failure led a very sedentary lifestyle. Anecdotally, physically active patients are most likely to experience subclavian crush.

In summary, this patient developed a compromising lead crush which may have resulted from a medial puncture to a subclavian vein which already contained three leads. As device implantation rates increase and patients with devices live longer, it is likely that more leads will be implanted. When using the subclavian route, care should be taken to avoid a very medial puncture, lead extraction should be considered early, and regular follow-up is required to minimize the potentially serious consequences of lead failure. Finally, the finding of multiple leads predisposing to lead crush needs to be validated in a large clinical cohort study.
