Right Coronary Artery to Coronary Sinus Fistula: Computed Tomography, Angiography and Echocardiography

Clinical Case Portal

Topics: Invasive Imaging: Cardiac Catheterisation and Angiography

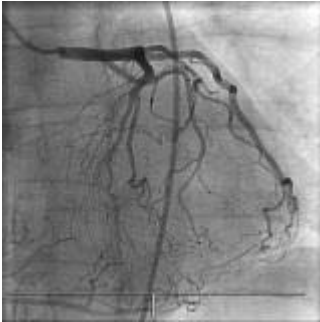
Fig. 1 :

[Right Coronary Artery to Coronary Sinus Fistula: Angiogram - LCA](#)

Left and right heart catheterisation showed normal left coronary anatomy with retrograde filling of the PDA (fig 1). The right coronary artery (fig. 2) was markedly dilated and occluded at the PDA. A coronary fistula was noted that was thought to drain to the coronary sinus. Right heart pressures were normal and the calculated left to right heart shunt ratio was 1.6:1.

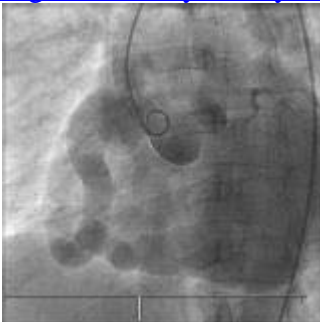
Fig. 2 :

[Right Coronary Artery to Coronary Sinus Fistula: Angiogram - LCA](#)

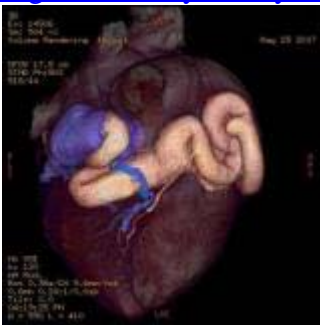
Fig. 5 :

[Right Coronary Artery to Coronary Sinus Fistula: Coronary CT RCA and coronary sinus](#)

Echocardiography showed a 'windsock' appearance of the right coronary sinus of valsalva and turbulent flow directed anteriorly consistent with ostial stenosis of the aneurysmal right coronary artery (fig. 3). The coronary sinus was also markedly dilated (fig. 5), and there was hyperdynamic flow from the coronary sinus to the right atrium (fig. 4). The Apical four chamber (fig. 6), parasternal short axis and subcostal four chamber views showed various portions of the right coronary artery in cross section consistent with the serpiginous nature of the vessel. The exact location of the fistulous connection could not be determined. There was mild global impairment of left ventricular systolic function. Cardiac valves were normal. There was mild bi-atrial dilatation. The right ventricle was normal size with normal systolic function. Left to right heart shunt ratio calculated by the continuity equation was 1.6:1.

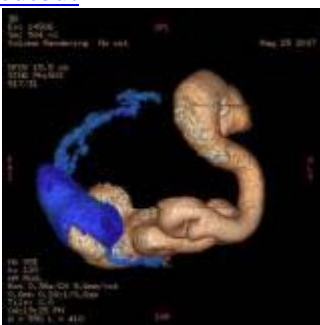
Fig. 6 :

[Right Coronary Artery to Coronary Sinus Fistula: Computed Tomography - RCA and coronary sinus cutout](#)

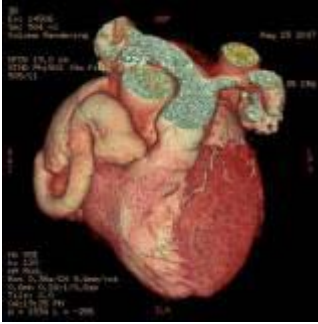
Fig. 7 :

[Right Coronary Artery to Coronary Sinus Fistula: Computed Tomography: Anterior view](#)

CT coronary Angiogram (fig. 7,fig. 8,fig. 9 and fig. 10) showed a large 'serpentine' vascular structure centred in the right atrio-ventricular groove consistent with known fistula. The proximal right coronary had a diameter of 32 mm. Beyond this the majority of the right coronary artery measured 20 - 25 mm. The distal portion of the vessel terminated in an aneurysmally dilated coronary sinus. The dilated terminal segment of the coronary sinus measured 20 mm in diameter. Left ventricular end diastolic volume was 210 ml and ejection fraction was 51%.

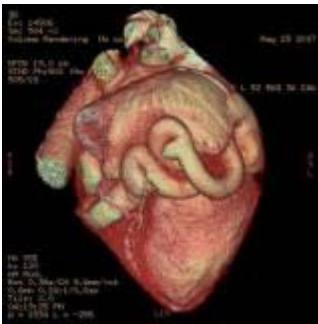
Fig. 8 :

[Right Coronary Artery to Coronary Sinus Fistula: Computed Tomography - Right side of the heart](#)
