Inducible ischaemia in the LAD by vasodilator MCE

Clinical Case Portal

Benoy Shah, Roxy Senior

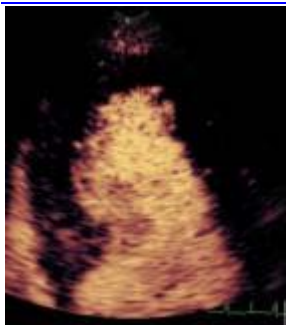
Fig. 7 :

C: Post-flash frame confirming good bubble destruction

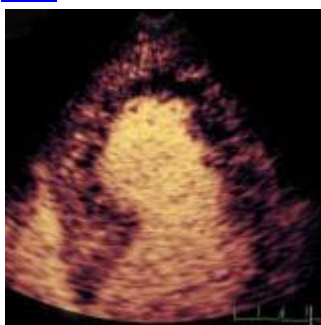
Fig. 8 :

D: Extensive perfusion defect (delayed refilling) extending from mid-apical septum through entire lateral wall

Flash imaging after dipyridamole stress (fig 6). Note the clear subendocardial perfusion defect - see fig 7-10 for the still images from this movie.
